**Flood Control Project Maintenance  
Levee Inspections**

## Maintenance Issue Types Only, Levee Inspection Report By Mile - Spring 2020

### Merced Streams Group

Waterway	Bank	Unit Miles	Inspection Start/End	Inspector
Unit No. 01 Black Rascal Diversion	Right	1.61	04/16/2020 04/16/2020	Corey Fujitani

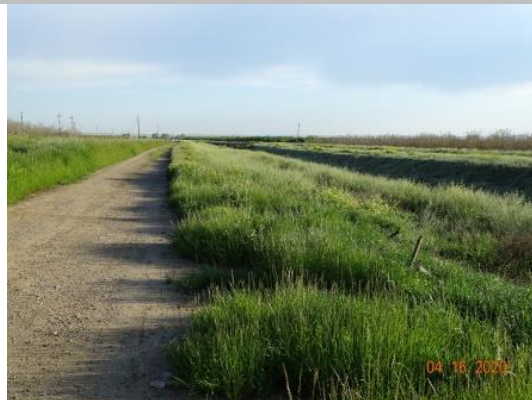
Photo 1 of 1 : SP\_2020\_NA0013\_331\_2\_20200504\_00015.jpg

LM Start	0.01	Rating **	U	Issue No.	2
LM End	1.61	Issue Type +	Ma	Location *	WS
Category	Earthen Levee			GPS Latitude/Longitude	
				Start	End
Item	Vegetation			37.314819 °	37.337083 °
				-120.396382 °	-120.396560 °
DWR ID	DWR_NA0013_01_f_2019_2				
Comment Code					
V1 : Control annual grass and weeds on the levee slopes and easements.					
Inspector Comment					
Control vegetation and remove thorny bushes growing at LM 1.45 to 1.61

Looking upstream along the waterside slope. (Spring 2020)

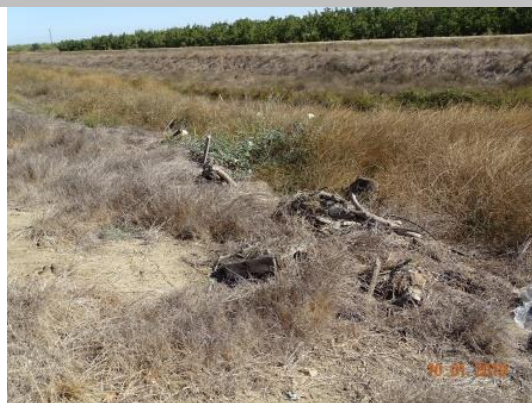
Photo 1 of 1 : SP\_2020\_NA0013\_331\_11\_20200225\_00006.jpg

LM Start	0.02	Rating **	M	Issue No.	11
LM End	0.02	Issue Type +	Ma	Location *	WS
Category	Earthen Levee			GPS Latitude/Longitude	
				Start	End
Item	Encroachments			37.314942 °	37.314942 °
				-120.396394 °	-120.396394 °
DWR ID	DWR_NA0013_01_f _ 2018_11				
Comment Code					
DE : Debris					
Inspector Comment					
There is garbage on the waterside slope.

Debris and garbage on waterside slope. (Fall 2019)

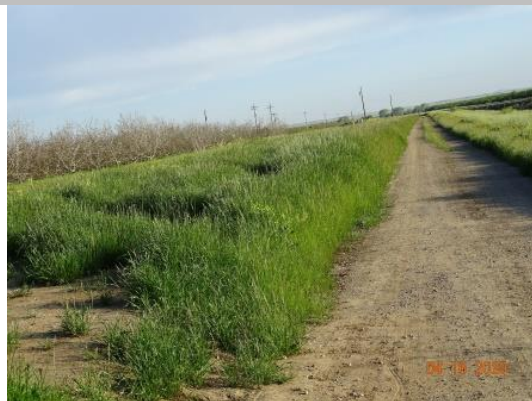
Photo 1 of 1 : SP\_2020\_NA0013\_331\_7\_20200505\_00016.jpg

LM Start	0.02	Rating **	U	Issue No.	7
LM End	0.43	Issue Type +	Ma	Location *	LS
Category	Earthen Levee			GPS Latitude/Longitude	
				Start	End
Item	Vegetation			37.314966 °	37.320765 °
				-120.396398 °	-120.396617 °
DWR ID	DWR_NA0013_01_s_2020_7				
Comment Code					
V1 : Control annual grass and weeds on the levee slopes and easements.					
Inspector Comment					
end at olive ave

View of vegetation growing on the landside slope. (Spring 2020)

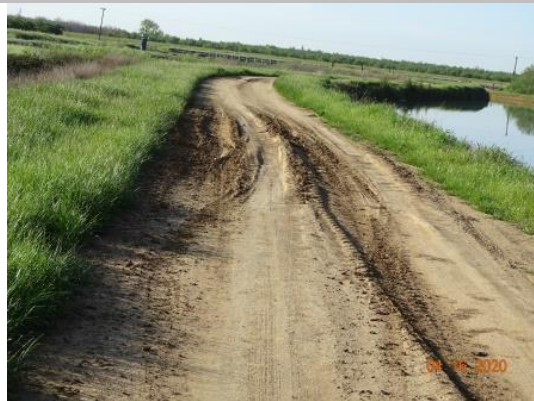
Photo 1 of 1 : SP\_2020\_NA0013\_331\_8\_20200505\_00017.jpg

LM Start	0.27	Rating **	M	Issue No.	8
LM End	1.62	Issue Type +	Ma	Location *	CR
Category	Earthen Levee			GPS Latitude/Longitude	
				Start	End
Item	Crown Surface / Depressions / Rutting			37.318525 °	37.337176 °
				-120.396598 °	-120.396531 °
DWR ID	DWR_NA0013_01_s_2018_8				
Comment Code					
C2 : Repair depressions or ruts in the crown or slope.					
Inspector Comment					
Vehicle tracks and rutting on the crown should be repaired.

View of vehicle tracks on the levee crown. (Spring 2020)

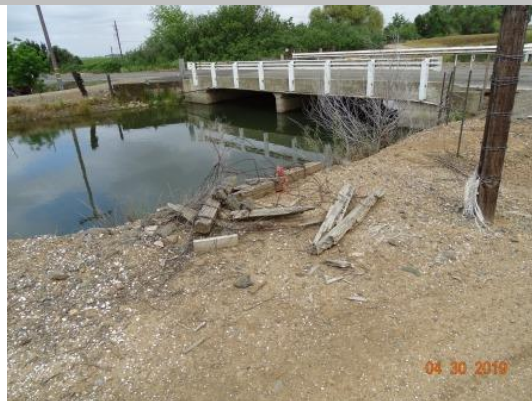
Photo 1 of 1 : SP\_2020\_NA0013\_331\_16\_20200225\_00010.jpg

LM Start	1.23	Rating **	M	Issue No.	16
LM End	1.23	Issue Type +	Ma	Location *	CR
Category	Earthen Levee			GPS Latitude/Longitude	
				Start	End
Item	Repair Gates			37.332005 °	37.332005 °
				-120.394751 °	-120.394751 °
DWR ID	DWR_NA0013_01_s _ 2019_16				
Comment Code					
Inspector Comment					
Gate has been removed.

View of barbed wire gate discarded on levee. (Spring 2019)

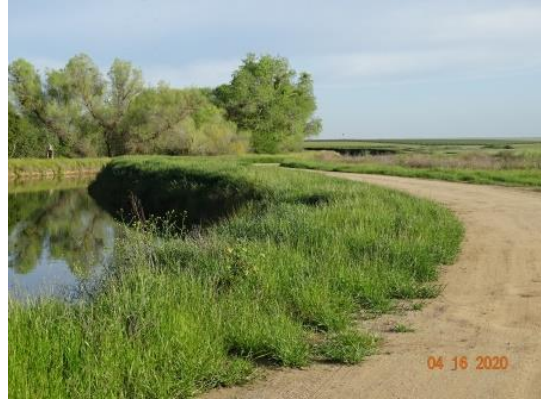
Photo 1 of 1 : SP\_2020\_NA0013\_331\_21\_20200505\_00018.jpg

Control the vegetation on the landside shoulder. (Spring 2020)

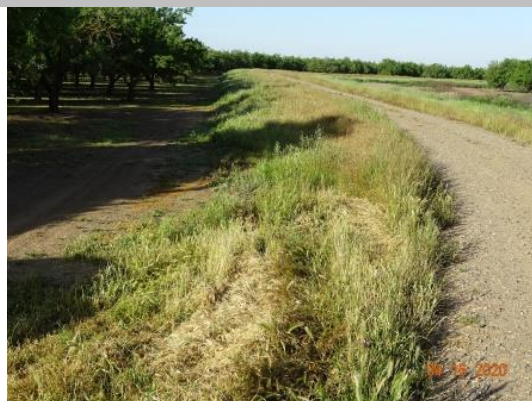
Photo 1 of 1 : SP\_2020\_NA0013\_332\_21\_20200505\_00046.jpg

Looking downstream along the landside slope. (Spring 2020)

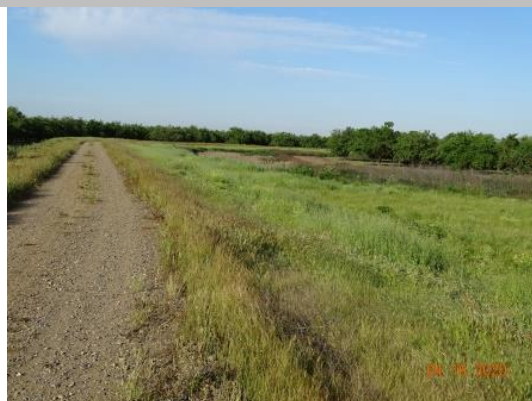
Photo 1 of 1 : SP\_2020\_NA0013\_332\_23\_20200505\_00048.jpg

LM Start	0.02	Rating **	U	Issue No.	23
LM End	1.85	Issue Type +	Ma	Location *	WS
Category	Earthen Levee			GPS Latitude/Longitude	
				Start	End
Item	Vegetation			37.336989 °	37.314609 °
				-120.387735 °	-120.395807 °
DWR ID	DWR_NA0013_02_s _ 2020_23				
Comment Code					
V1 : Control annual grass and weeds on the levee slopes and easements.					
Inspector Comment

Maintain grass vegetation on the waterside slope. (Spring 2020)

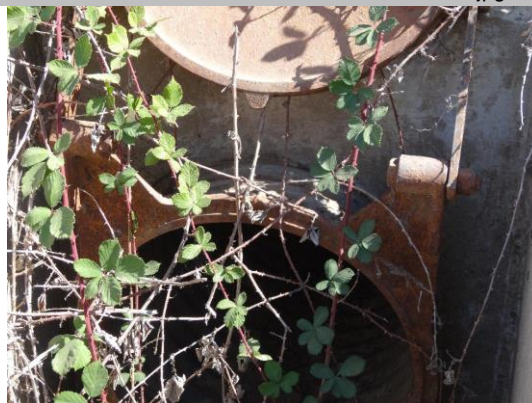
Photo 2 of 3 : UCIP\_SP\_2020\_50156\_35244.jpg

WS view: U typed concrete headwall, CM pipe, and flap gate. Flap gate was not closed. Vegetation needs to be cleared.

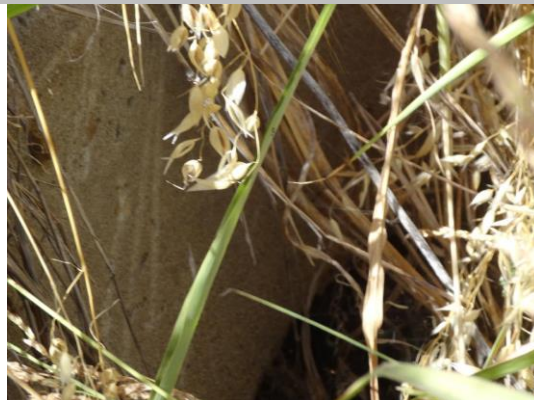
Photo 3 of 3 : UCIP\_SP\_2020\_20946\_35264.jpg

LS view: concrete headwall and CM pipe. Inlet needs cleaning.

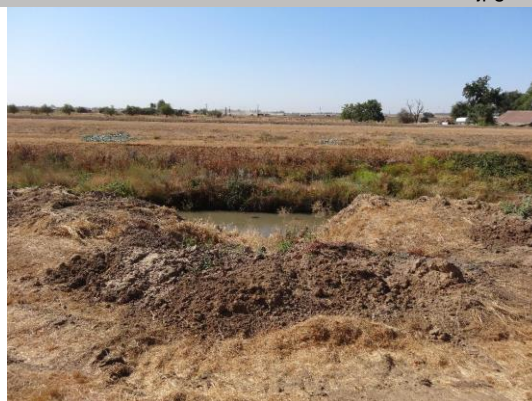
Photo 1 of 3 : UCIP\_SP\_2020\_20992\_35370.jpg

Comment Code						
Inspector Comment						
DS_ID:23055						
FS_ID:20992						
EP_NO: N/A						
Repair Type: Non-Urgent						
Crossing Status: Found						
UCIP Comments: 09/17/2013 - mud and debris from recent channel cleaning needs to be removed from spillway and outlet - pipe filled with debris, it needs cleaning.- half of inlet pipe buried. (DWR UCIP - P. Amatya)						
FIELD_STRUCT_DESC: 24-inch corrugated metal gravity drainage pipe through the levee, 8 feet below the crown. Concrete headwall, flap gate, and concrete grouted cobble spillway on the waterside (WS) toe. Concrete headwall on the landside (LS) toe. [Additional Reference(s): DWR Levee Log, 2005. USACE San Joaquin O&M Manual 607, June 1962, (HLM 0.73)].						
FS Date: 9/17/2013

WS view: concrete headwall and CM pipe buried under debris and mud.

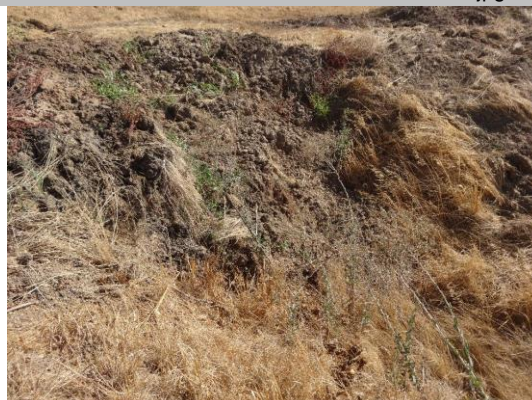
Photo 2 of 3 : UCIP\_SP\_2020\_20992\_35369.jpg

WS view: debris and mud deposited from the channel cleaning. It needs to be cleared from spillway and outlet structure.

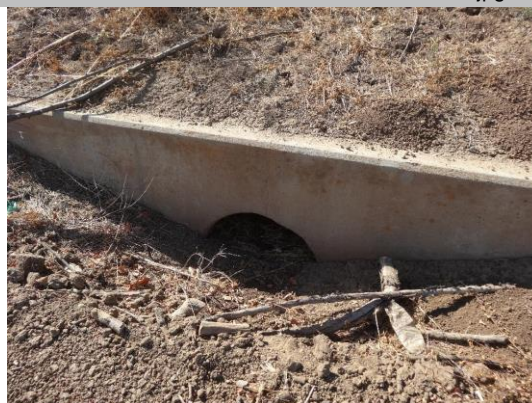
Photo 3 of 3 : UCIP\_SP\_2020\_20992\_35366.jpg

LS view: concrete headwall and CM pipe. Half of inlet pipe buried.

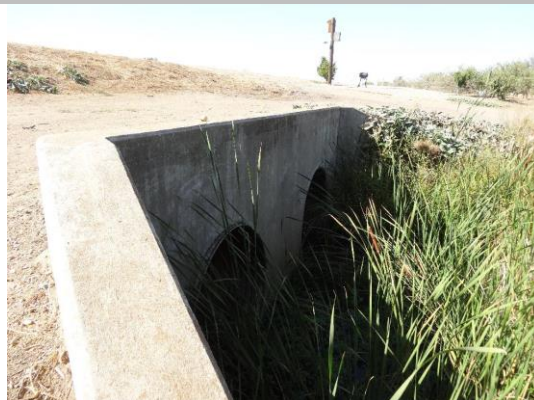
Photo 2 of 3 : UCIP\_SP\_2020\_20983\_35301.jpg

LS view: U typed concrete headwall, two CMPs in drainage ditch. Dense vegetation in drainage ditch.

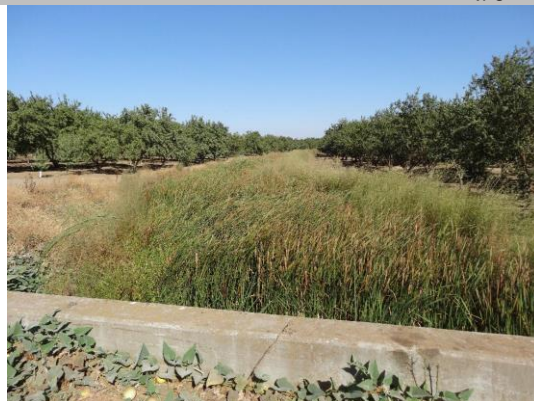
Photo 3 of 3 : UCIP\_SP\_2020\_20983\_35300.jpg

LS view: concrete headwall in drainage ditch. Dense vegetation in drainage ditch.

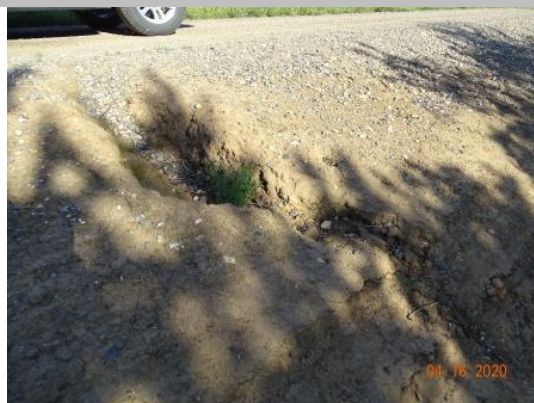
Photo 1 of 1 : SP\_2020\_NA0013\_332\_15\_20200505\_00049.jpg

LM Start	0.97	Erosion **	M	Issue No.	15
LM End	0.97	Issue Type +	Ma	Location *	LS
Category	Earthen Levee			GPS Latitude/Longitude	
				Start	End
Item	Erosion / Bank Caving			37.327336 °	37.327336 °
				-120.396085 °	-120.396085 °
DWR ID	DWR_NA0013_02_f_2017_15				
Comment Code					
E2 : Schedule repair of erosion site prior to the next inspection.					
Inspector Comment					
There is large finger erosion on the landward slope. Couple of smaller erosion sites are starting just downstream of the larger erosion.

Looking at finger erosion on the landside slope. (Spring 2020)

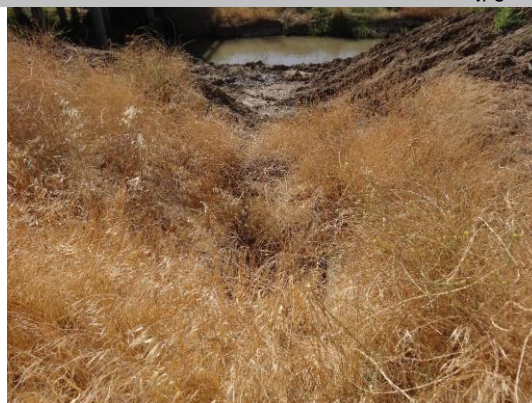
Photo 1 of 3 : UCIP\_SP\_2020\_42993\_35310.jpg

Comment Code					
Inspector Comment					
DS_ID:23058 FS_ID:42993 EP_NO: N/A Repair Type: Non-Urgent Crossing Status: Found UCIP Comments: 09/17/2013 - needs cleaning of debris on spillway on WS. Flapgate blocked by debris on WS. - needs cleaning inside CMP on LS. (DWR UCIP - P. Amatya) FIELD_STRUCT_DESC: 24-inch corrugated metal gravity drainage pipe through the levee, 8 feet below the crown. Concrete headwall, flap gate, and concrete grouted cobble spillway on the waterside (WS) toe. Concrete headwall on the landside (LS) toe. [Additional Reference(s): DWR Levee Log, 2005. USACE San Joaquin O&M Manual 607, June 1962, (HLM 1.64)]. FS Date: 9/17/2013

WS view: overview of outlet area and channel. Debris and vegetations on spillway.

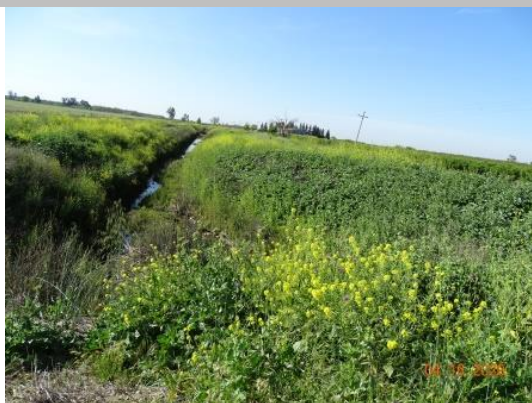
Photo 1 of 1 : SP\_2020\_NA0013\_333\_15\_20200505\_00032.jpg

View of vegetation on the waterside slope. (Spring 2020)

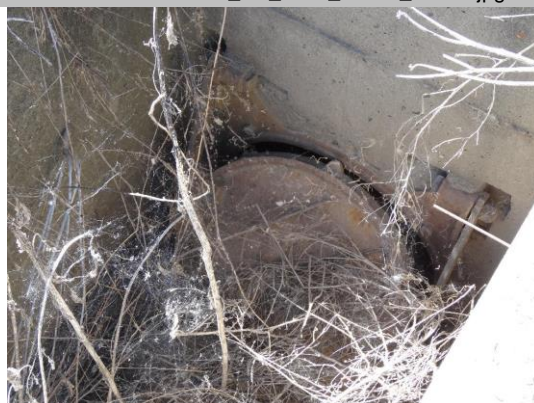
Photo 2 of 3 : UCIP\_SP\_2020\_50144\_35421.jpg

WS view: U typed concrete headwall, CM pipe, and flap gate. Damaged flap gate.

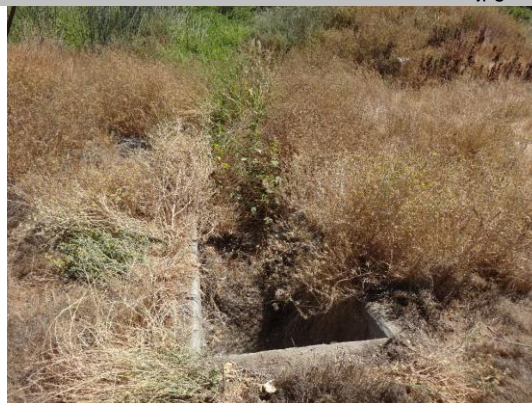
Photo 1 of 3 : UCIP\_SP\_2020\_50149\_35535.jpg

WS view: cobble spillway and channel on waterside. Dense vegetation on levee slope.

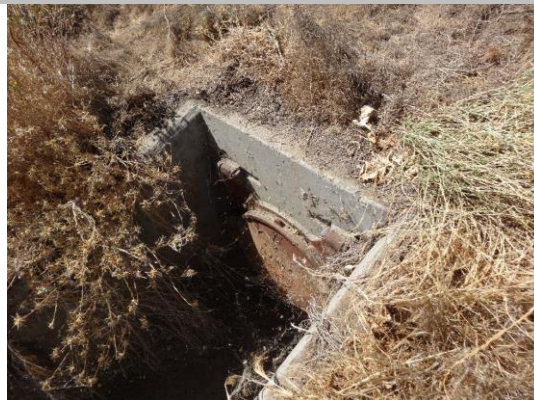
Photo 2 of 3 : UCIP\_SP\_2020\_50149\_35534.jpg

WS view: U typed concrete headwall, CM pipe, and flap gate. Vegetation needs to be cleared.

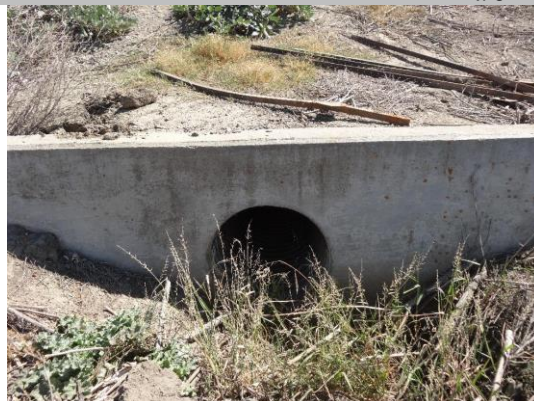
Photo 3 of 3 : UCIP\_SP\_2020\_50149\_35537.jpg

LS view: concrete headwall and CM pipe. Inlet needs clearing.

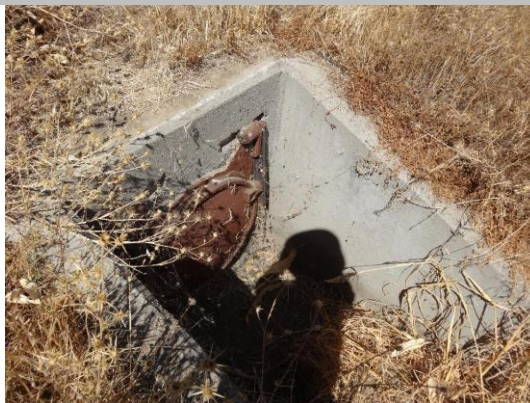
Photo 2 of 3 : UCIP\_SP\_2020\_50151\_35538.jpg

WS view: U typed concrete headwall, CM pipe, and flap gate. Vegetation needs to be cleared.

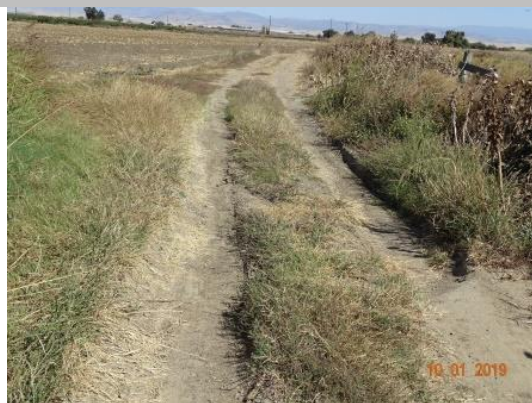
Photo 1 of 1 : SP\_2020\_NA0013\_333\_9\_20200225\_00001.jpg

View of rutted levee crown looking upstream. (Fall 2019)

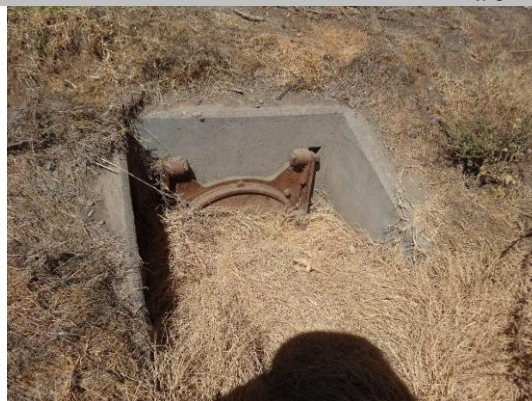
Photo 2 of 3 : UCIP\_SP\_2020\_50152\_35543.jpg

WS view: U typed concrete headwall, CM pipe, and flap gate. Vegetation needs to be cleared.

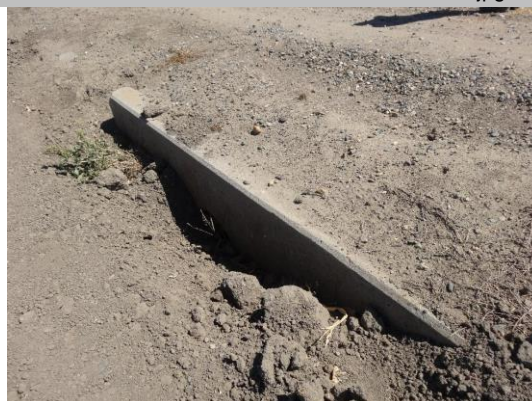
Photo 3 of 3 : UCIP\_SP\_2020\_50152\_35542.jpg

LS view: concrete headwall and CM pipe. Inlet needs clearing &amp;

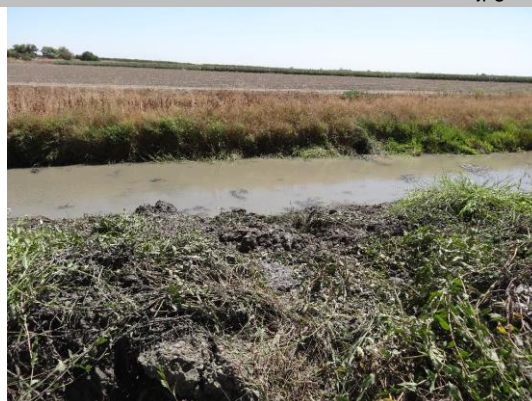
Photo 1 of 3 : UCIP\_SP\_2020\_21063\_35502.jpg

WS view: U typed concrete headwall, CM pipe, and flap gate buried under mud/debris.

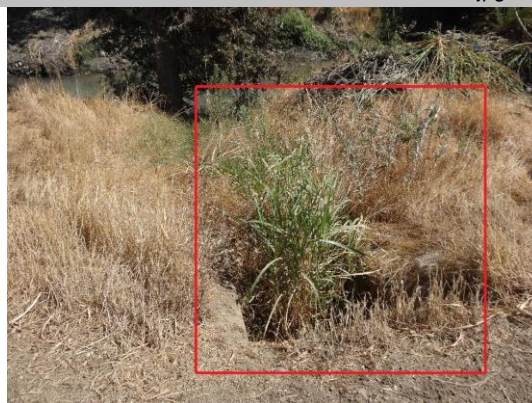
Photo 1 of 3 : UCIP\_SP\_2020\_21064\_35506.jpg

WS view: cobble spillway and channel on waterside. Dense vegetation on levee slope and spillway.

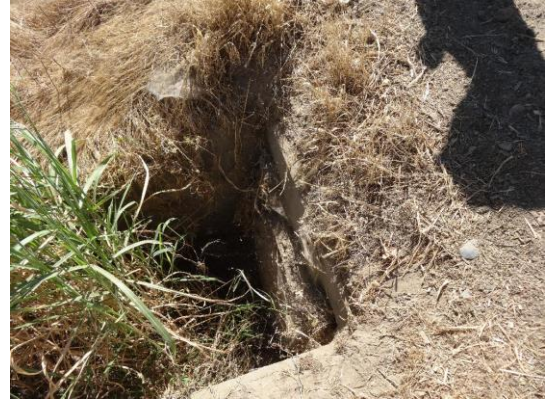
Photo 2 of 3 : UCIP\_SP\_2020\_21064\_35505.jpg

WS view: U typed concrete headwall, CM pipe, and flap gate. Vegetation needs to be cleared.

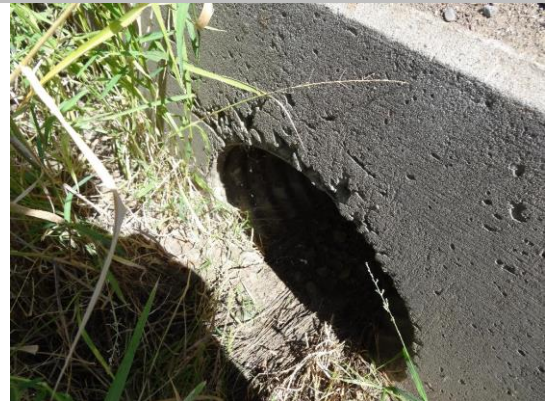
Photo 3 of 3 : UCIP\_SP\_2020\_21064\_35504.jpg

LS view: concrete headwall and CM pipe. Inlet needs clearing.

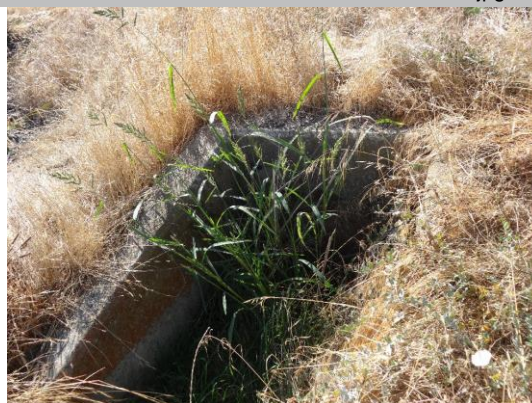
Photo 1 of 3 : UCIP\_SP\_2020\_42991\_35751.jpg

WS view: concrete spillway and channel on waterside. Dense vegetation on levee slope and spillway.

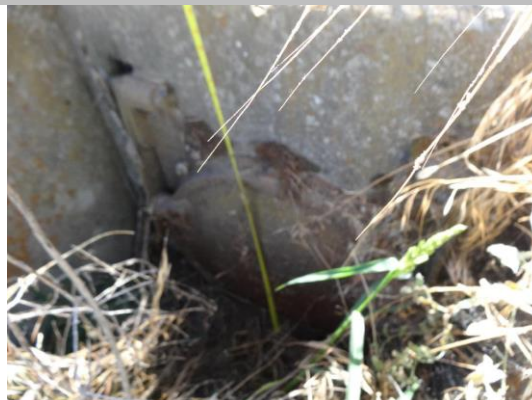
Photo 2 of 3 : UCIP\_SP\_2020\_42991\_35750.jpg

WS view: U typed concrete headwall, CM pipe, and flap gate. Vegetation and silt need to be cleared.

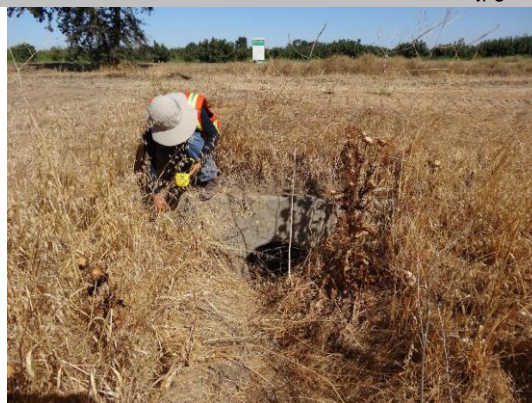
Photo 3 of 3 : UCIP\_SP\_2020\_42991\_35749.jpg

LS view: concrete headwall and CM pipe. Inlet silt needs clearing.

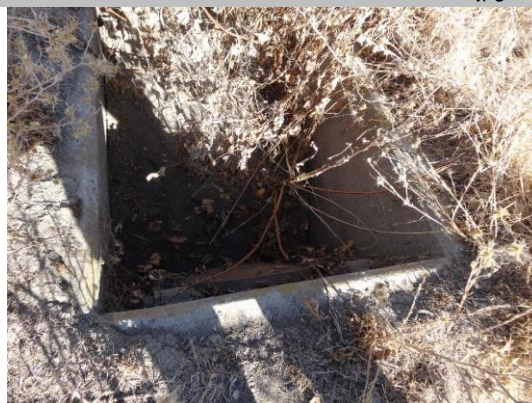
Photo 1 of 3 : UCIP\_SP\_2020\_50146\_35748.jpg

WS view: U typed concrete headwall, CM pipe, and flap gate. Vegetation needs to be cleared.

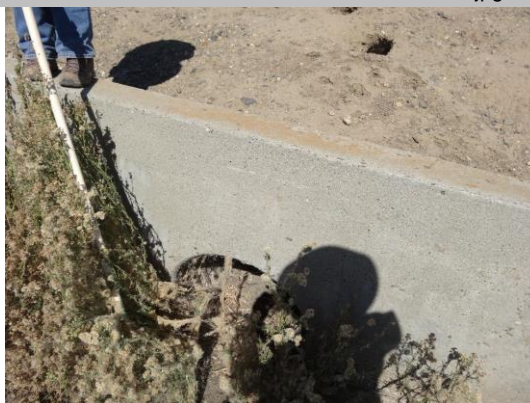
Photo 2 of 3 : UCIP\_SP\_2020\_50146\_35747.jpg

LS view: concrete headwall and CM pipe. Inlet needs clearing.

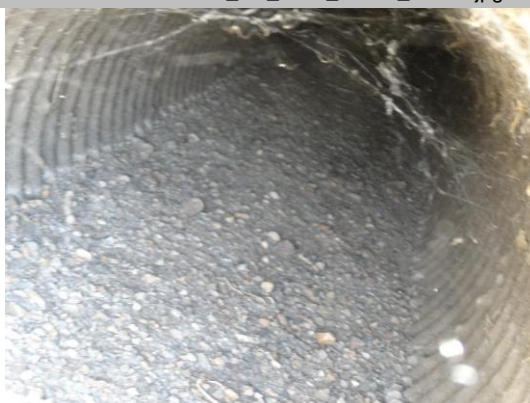
Photo 3 of 3 : UCIP\_SP\_2020\_50146\_35746.jpg

LS view: inside view of CM pipe. Inlet pipe needs clearing.

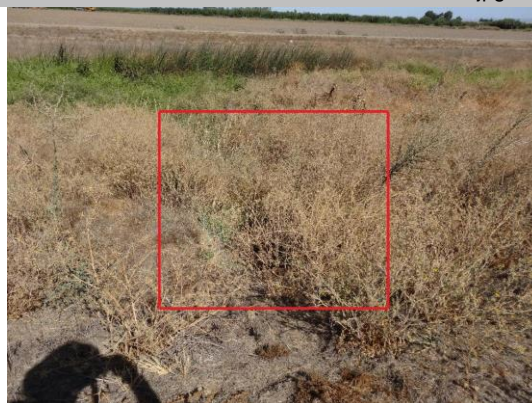
Photo 1 of 3 : UCIP\_SP\_2020\_50154\_35608.jpg

WS view: Dense vegetation on levee slope and spillway.

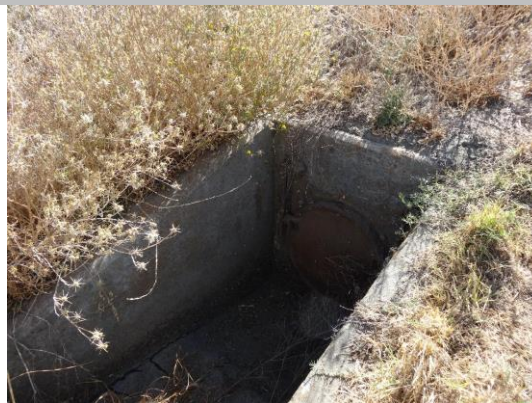
Photo 2 of 3 : UCIP\_SP\_2020\_50154\_35607.jpg

WS view: U typed concrete headwall, CM pipe, and flap gate. Vegetation needs to be cleared on spillway.

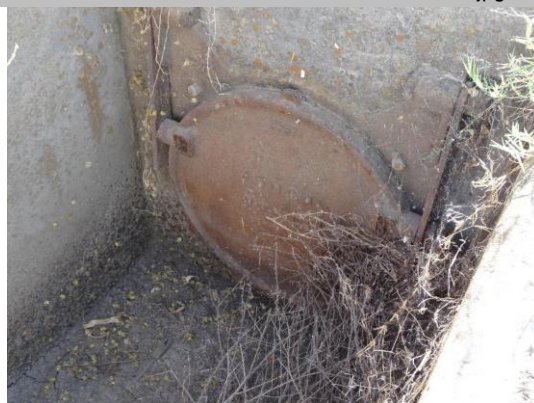
Photo 3 of 3 : UCIP\_SP\_2020\_50154\_35606.jpg

WS view: CM pipe and flap gate. Vegetation needs to be cleared.

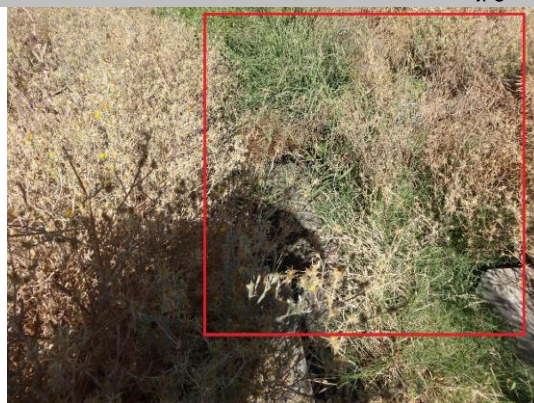
Photo 1 of 3 : UCIP\_SP\_2020\_50148\_35613.jpg

WS view: Dense vegetation on levee slope and spillway.

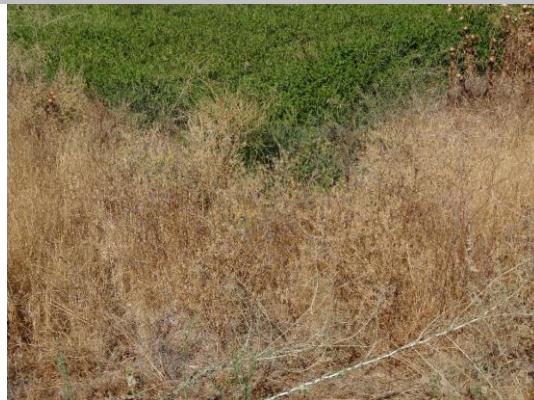
Photo 1 of 3 : UCIP\_SP\_2020\_50155\_35642.jpg

WS view: Dense vegetation on levee slope and spillway.

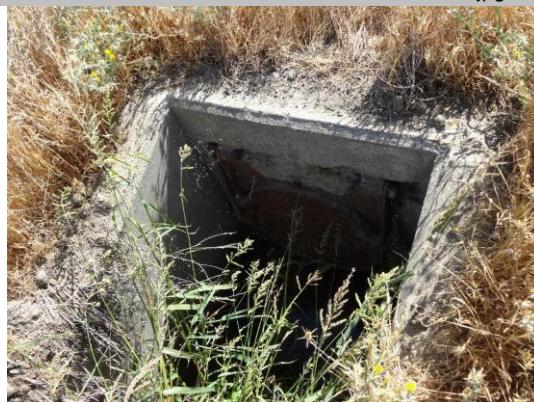
Photo 2 of 3 : UCIP\_SP\_2020\_50155\_35641.jpg

WS view: U typed concrete headwall, CM pipe, and flap gate. Vegetation needs to be cleared.

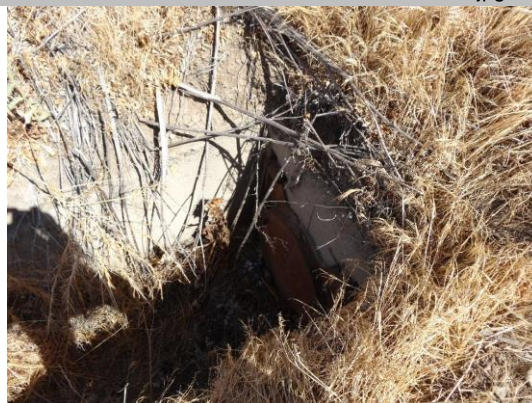
Photo 1 of 3 : UCIP\_SP\_2020\_52888\_35709.jpg

DS\_ID:23075  
FS\_ID:52888  
EP\_NO: N/A  
Repair Type: Non-Urgent  
Crossing Status: Found  
UCIP Comments: 09/17/2013 - needs clearing on both inlet and outlet.

WS view: concrete spillway and channel on waterside. Dense vegetation on levee slope and spillway.

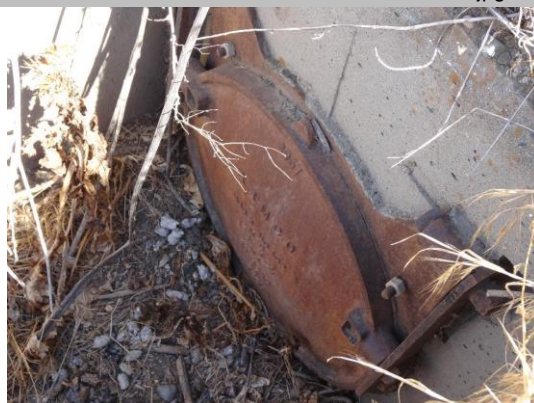
Photo 2 of 3 : UCIP\_SP\_2020\_52888\_35708.jpg

WS view: U typed concrete headwall, CM pipe, and flap gate. Spillway needs to be cleared.

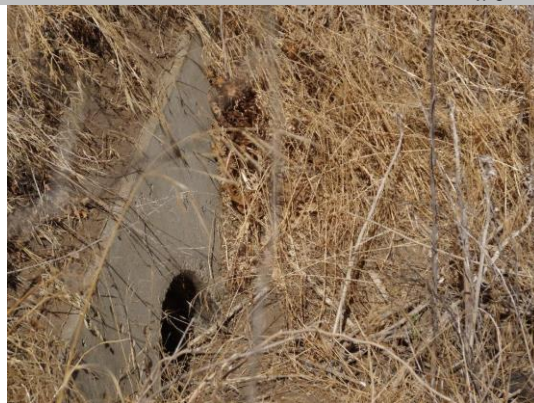
Photo 3 of 3 : UCIP\_SP\_2020\_52888\_35707.jpg

LS view: concrete headwall and CM pipe. Inlet silt needs clearing.

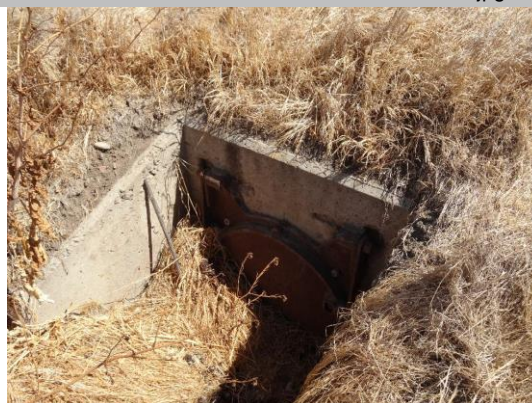
Photo 1 of 3 : UCIP\_SP\_2020\_50153\_35745.jpg

WS view: U typed concrete headwall, CM pipe, and flap gate. Dirt and vegetations need to be removed and cleared.

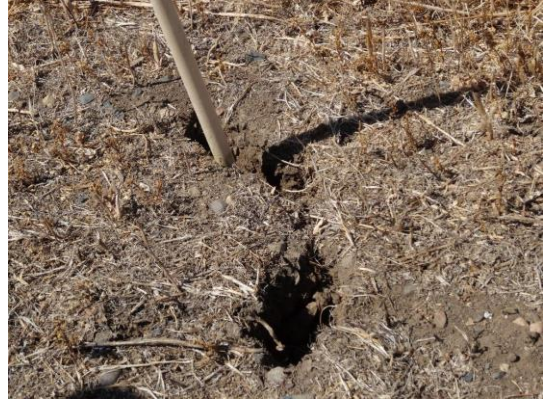
Photo 2 of 3 : UCIP\_SP\_2020\_50153\_35744.jpg

WS view: significant levee cracks along the pipealignment. Needs detailed investigation on the issue.

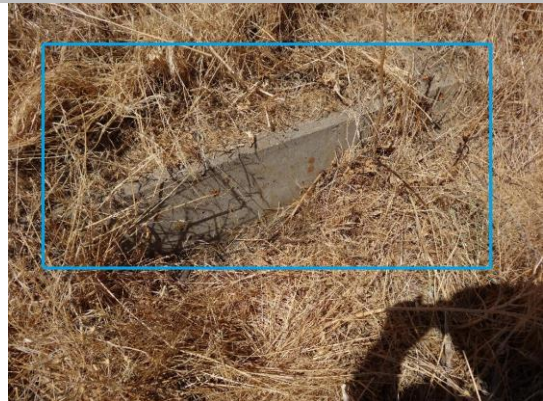
Photo 3 of 3 : UCIP\_SP\_2020\_50153\_35743.jpg

LS view: concrete headwall and burried CM pipe. Dirt removal and clearing needed in inlet.
